## 冷凝液汽提塔塔盘腐蚀失效机理研究

(广西壮族自治区特种设备检验研究院, 南宁 530299)

**摘 要:** 冷凝液汽提塔作为煤化工酸性水处理系统的核心设备,其运行稳定性直接关系到装置安全与资源回收效率。针对某冷凝液汽提塔运行 1 年后出现的塔盘与筒体严重腐蚀问题,采用宏观和微观形貌观察、化学成分分析、物相组成测试等方法对腐蚀产物进行了表征,同时结合汽提塔回流液的物性参数,分析了塔盘腐蚀失效机理。结果表明:回流液中腐蚀介质高度富集,氰根离子浓度为 1.78 mmol/L,  $\text{NH}_3\text{-N}$  浓度高达 1 408 mmol/L;塔盘存在大面积蚀穿和密集腐蚀坑,金属表面呈现典型的冲刷沟槽形貌;腐蚀产物主要呈蓝绿色,主要组成为亚铁氰化铁( $\text{Fe}_4[\text{Fe}(\text{CN})_6]_3$ )。塔盘腐蚀失效的主要机理为:回流系统引起的酸性介质富集导致电化学腐蚀,同时塔内高速气液两相流对金属表面造成持续冲刷,两者的协同作用导致设备在短期内发生严重失效。基于上述结果,从工艺调控与材料防护两方面提出了针对性的防护措施,研究结果可为同类设备的防腐设计提供参考。

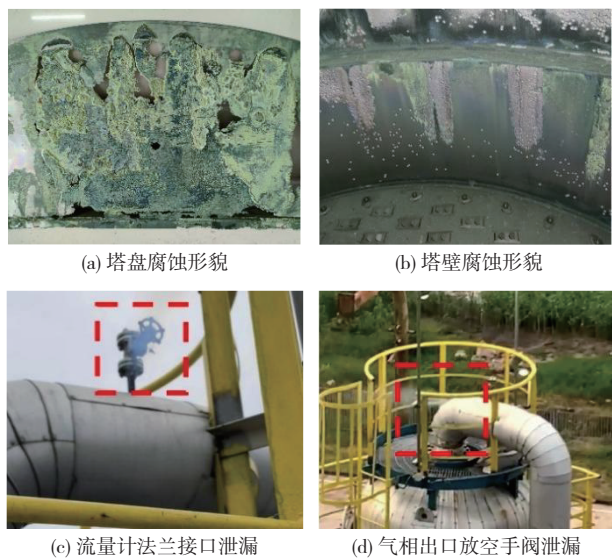
图2 汽提塔的腐蚀及泄漏情况

两套同型号冷凝液汽提塔在投运1年后均出现相似的腐蚀特征,塔体上部区域频繁发生泄漏,处理效率显著降低。18层塔盘自上而下均存在不同程度的腐蚀,上部腐蚀最为严重,向下依次递减(图2(a))。除塔盘严重腐蚀外,作为承压部件的塔壁也存在较为严重的腐蚀,腐蚀情况与塔盘类似,其表面分布有密集的腐蚀凹坑,局部连通的孔洞共同构成蜂窝状形貌(图2(b))。与腐蚀相伴的还有冷凝液汽提塔流量计法兰接口泄漏(图2(c))、气相出口放空手阀泄漏(图2(d))等情况。

产物,造成塔盘大面积均匀减薄。同时,塔壁表面分布有大量腐蚀坑(图2(b)),其形成与多相流作用下腐蚀产物膜的非同步剥离密切相关。剥离通常始于膜层中的结构缺陷或薄弱区域,这些区域首先形成微型气孔,而气孔内流动滞止区延长了介质作用时间并诱发涡流,微孔不断扩展并与邻近孔洞相互连通,最终演变为宏观腐蚀孔<sup>[21]</sup>。综合而言,冲刷作用不仅加速材料流失,而且通过改变表面形貌与局部流体状态,促进了多种腐蚀形态的萌生与扩展。

(1)工艺调控方面,对现有回流工艺进行优化改造,可采用部分回流以及塔顶冷凝液部分外排的措施,降低酸性气体在塔内的循环累积。这些措施可显著改善塔内运行环境的稳定性,避免形成局部高腐蚀强度区域,从而从整体上降低设备的腐蚀风险。

(2)材料优化方面,由于传统铁基材料在复杂腐蚀介质与高速流体的协同作用下耐蚀性明显不足,因此可以选用耐蚀性更好的双相不锈钢(如S32205)或镍基合金(如Hastelloy C-276)作为替代材料。研究证实,这类材料在含有 $Cl^-$ 、 $H_2S$ 、 $CN^-$ 等成分的复杂腐蚀环境中表现出优异的抗点蚀、抗缝隙腐蚀及抗冲刷腐蚀能力<sup>[22-23]</sup>。

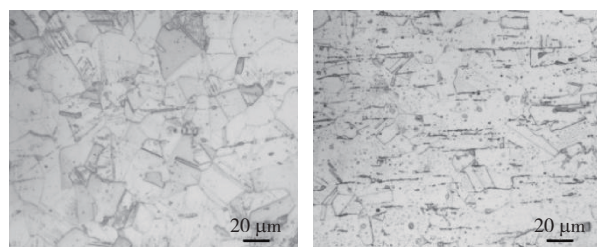
图3 塔盘板基体的光学显微镜照片

采用直读光谱仪测定塔盘板基体的化学元素组成,并将测试结果与国家标准 GB/T 24511—2017《承压设备用不锈钢和耐热钢钢板和钢带》<sup>[11]</sup>进行对比,结果如表3所示。根据检测结果可以推断,失效塔板所用材料(S31603)的元素含量基本符合标准要求,但Mo元素含量略低于标准值,这会降低材料在酸性介质中的局部腐蚀抵抗力<sup>[12]</sup>。

采用光学显微镜观察塔盘板基体的微观形貌,结果见图3。图3显示,该板材主要由奥氏体基体构成,组织中可见较为明显的带状分布特征,未观察到晶粒异常长大、有害相析出以及其他与材料劣化相关的结构异常。

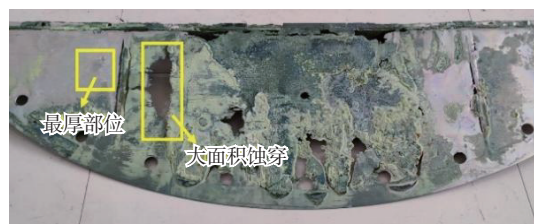
(a) 蚀穿表面

图4为受液盘的宏观腐蚀形貌。由图4(a)可以看出样品表面遭受了不同程度的腐蚀,两个筋板之间布满腐蚀产物,伴随大面积的蚀穿和腐蚀坑,腐蚀包括均匀腐蚀和点蚀等,无固定规律。受液盘最厚位置的厚度为2.29 mm,而已蚀穿部位的周边金

属部分非常薄,最薄处仅0.38 mm,塔板加工成型时的横向纹路清晰可见。塔盘表面的腐蚀产物分为两种状态:一种为聚集态黄绿色粉末,成簇聚集在部件的转角处以及两块钢板的间隙位置;另一种为

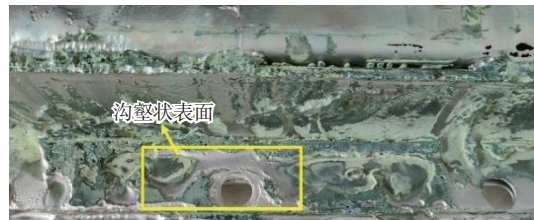
(b) 沟壑状表面

蓝绿色膜状,紧附在不锈钢金属外表面,用刀片可轻易刮掉。图4(b)显示,腐蚀坑为洁净的哑光银色金属本体,露出的金属本体表面纹理清晰,呈冲刷状壑沟。结合上述分析,可以初步推断塔板在单相流或多相流以及腐蚀介质的作用下发生了冲刷腐蚀和电化学腐蚀。

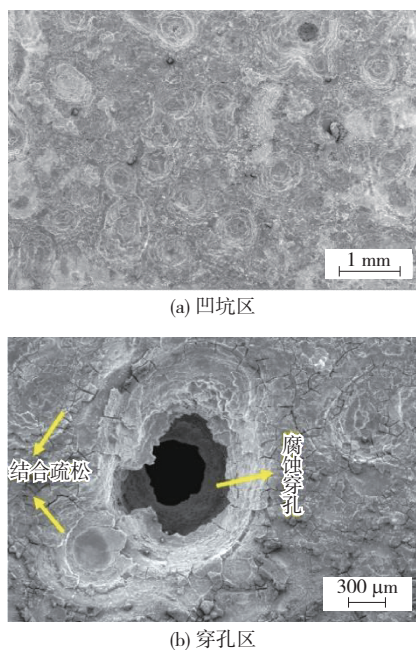
图5 塔盘板的SEM照片

采用SEM观察塔盘板的微观腐蚀形貌,结果如图5所示。图5显示,样品表面分布有大量形状不规则、尺寸各异的腐蚀凹坑,所有凹坑均呈现流线形轮廓(图5(a)),表明其形成与工艺介质的持续冲刷密切相关。部分凹坑内部可见腐蚀产物堆积,并呈现典型的多层“树皮状”结构,层间结合疏松,存在明显缝隙,并且表面存在多个上宽下窄的贯穿性孔洞(图5(b))。除腐蚀坑外,其余基体表面相对平整,但可见因流体作用导致的腐蚀产物不均匀分布痕迹,这与王凯等<sup>[13]</sup>观察到的现象一致。

对图5(a)中已发生腐蚀的区域进行EDS半定量分析,结果见表4。腐蚀产物中除检测出基体元素Fe、Cr和Mn外,还检测出含量较高的O、N与S元素,可以推测电化学腐蚀是导致设备失效的原因之一<sup>[14]</sup>。

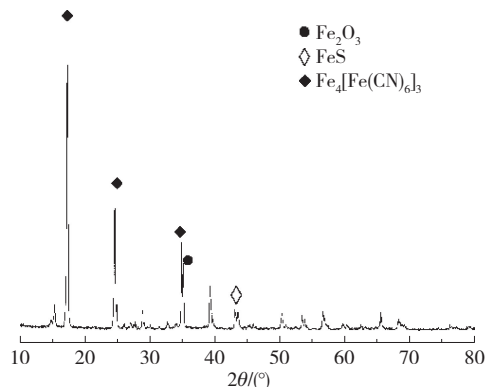
图6 腐蚀产物的XRD谱图

图6为腐蚀产物的XRD谱图。图6显示腐蚀产物的结晶度较高,其特征峰位与 $\text{Fe}_4[\text{Fe}(\text{CN})_6]_3$ 的特

征峰( $2\theta=17.49^\circ$ 、 $24.83^\circ$ 和 $35.41^\circ$ )基本相吻合,此外样品中还存在 $\text{FeS}$ ( $2\theta=43.25^\circ$ )和 $\text{Fe}_2\text{O}_3$ ( $2\theta=35.69^\circ$ )的特征峰。 $\text{Fe}_4[\text{Fe}(\text{CN})_6]_3$ 的检出从物相层面证实 $\text{CN}^-$ 在腐蚀过程中的关键作用。 $\text{CN}^-$ 与溶出的 $\text{Fe}^{2+}/\text{Fe}^{3+}$ 形成稳定络合物,并进一步沉积为具有典型普鲁士蓝颜色的腐蚀产物,该现象与塔盘及筒体表面广泛分布的蓝绿色区域相对应<sup>[15]</sup>。 $\text{FeS}$ 的存在反映 $\text{H}_2\text{S}$ 参与了电化学腐蚀路径,而 $\text{Fe}_2\text{O}_3$ 的存在表明腐蚀环境中存在氧化性条件。
