# Wear of contact strip in high-speed trains: a review

**Paper type** General review

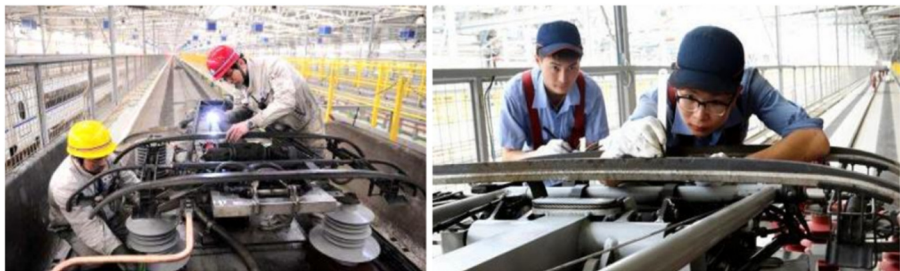
**Figure 7.** Technicians measuring wear on the CS. **Source(s):** [Lu et al. \(2021\)](#)

Current methods for assessing CS wear are primarily based on direct measurement techniques. This procedure requires skilled technicians to accurately identify the extent of wear, as illustrated in [Figure 7](#). After the train is brought into the depot and fully de-energized, personnel must climb onto the roof and use specialized measurement instruments to determine the CS thickness, locate worn areas, and evaluate material loss. While this approach is simple and straightforward to implement, it is relatively complex in practice due to the need for power shutdown and manual roof access. Furthermore, measurement results are highly influenced by human factors, introducing potential errors in identifying the most worn regions. In addition, this method only collects thickness values at discrete points, limiting the ability to accurately assess the overall wear morphology of the entire CS surface ([Lu, Liu, Li, & Shen, 2021](#)).

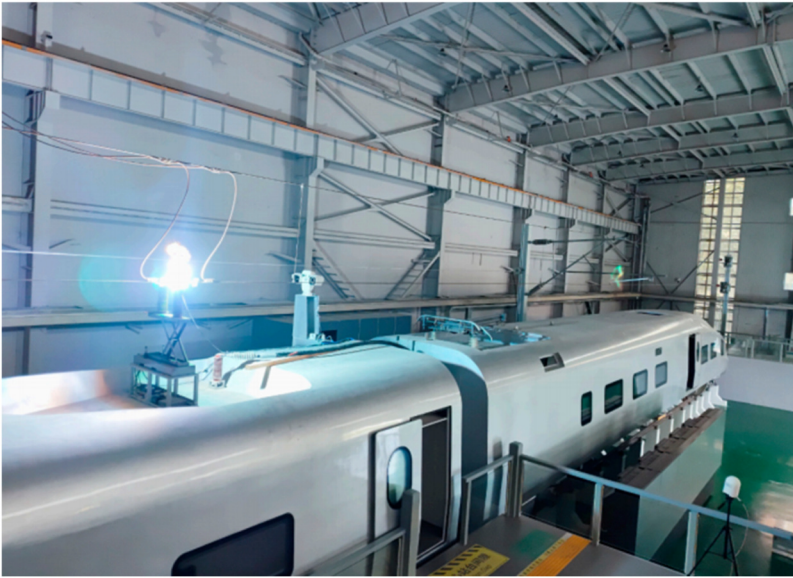
**Figure 10.** Arc phenomenon between the CL and pantograph. **Source(s):** [Yang et al. \(2024b\)](#)

Besides mechanical wear caused by friction, another issue that has received considerable attention and severely affects the CS surface is electrical arcing. Electrical arcs can result in carbon strip erosion, damage to the CL, and interruption of power supply, while also generating interference in communication signals, which directly impacts train operation and poses a threat to operational safety.
