## 冷凝液汽提塔塔盘腐蚀失效机理研究

(广西壮族自治区特种设备检验研究院, 南宁 530299)

**摘 要:** 冷凝液汽提塔作为煤化工酸性水处理系统的核心设备,其运行稳定性直接关系到装置安全与资源回收效率。针对某冷凝液汽提塔运行 1 年后出现的塔盘与筒体严重腐蚀问题,采用宏观和微观形貌观察、化学成分分析、物相组成测试等方法对腐蚀产物进行了表征,同时结合汽提塔回流液的物性参数,分析了塔盘腐蚀失效机理。结果表明:回流液中腐蚀介质高度富集,氰根离子浓度为 1.78 mmol/L,  $\text{NH}_3\text{-N}$  浓度高达 1 408 mmol/L;塔盘存在大面积蚀穿和密集腐蚀坑,金属表面呈现典型的冲刷沟槽形貌;腐蚀产物主要呈蓝绿色,主要组成为亚铁氰化铁( $\text{Fe}_4[\text{Fe}(\text{CN})_6]_3$ )。塔盘腐蚀失效的主要机理为:回流系统引起的酸性介质富集导致电化学腐蚀,同时塔内高速气液两相流对金属表面造成持续冲刷,两者的协同作用导致设备在短期内发生严重失效。基于上述结果,从工艺调控与材料防护两方面提出了针对性的防护措施,研究结果可为同类设备的防腐设计提供参考。

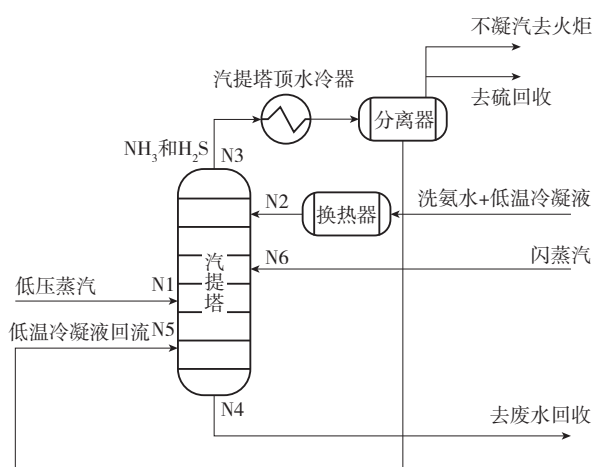
图1 冷凝液汽提塔工艺流程

冷凝液汽提塔的工艺流程如图1所示。经除氧处理的锅炉水产生的闪蒸汽由N6口进入塔内,低压饱和蒸汽从N1口输入,与自塔顶N2口进入的冷凝液形成气液两相逆流接触。在高温蒸汽作用下,冷凝液中的 $\text{NH}_3$ 和 $\text{H}_2\text{S}$ 被汽提析出,形成的气相混合物从塔顶N3口排出,经冷却分离后,不凝汽送火炬处理,净化冷凝液由塔底N4回收。分离器中的含氨液体经N5泵送回塔内进行进一步汽提,形成循环回路。该汽提塔的工艺参数如表1所示。低温冷凝液与低压蒸汽的实际流量均高于设计值,这可能会对设备腐蚀进程产生潜在影响。
